Your survey and valuation report

17 Springfield Crescent,
Somercotes, ALFRETON,
Derbyshire DE55 4LG

3rd March 2026

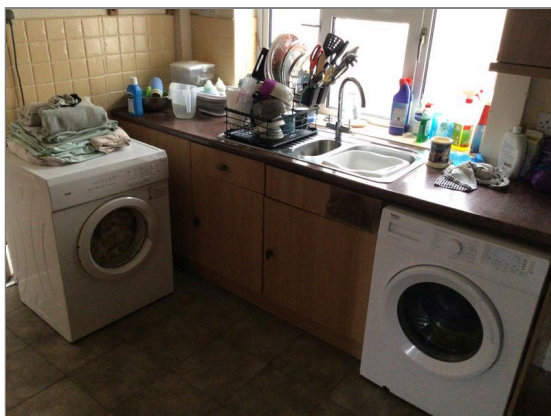
Photo - 5 Kitchen units

The kitchen contains old fittings that are nearing the end of their useful life and are likely to require renewal. None of the appliances were tested. All seals around worktops, sinks and units should be kept in good condition to prevent water penetration, which can damage adjacent timbers and finishes. Kitchens are prone to condensation and mould, so a suitable balance of background heating, insulation and effective ventilation is important; mechanical extract ventilation is recommended and vents should be cleaned regularly. Built-in kitchen units can conceal defects such as leaks, dampness or hidden pipework, and further issues may become apparent when the fittings are removed for replacement.

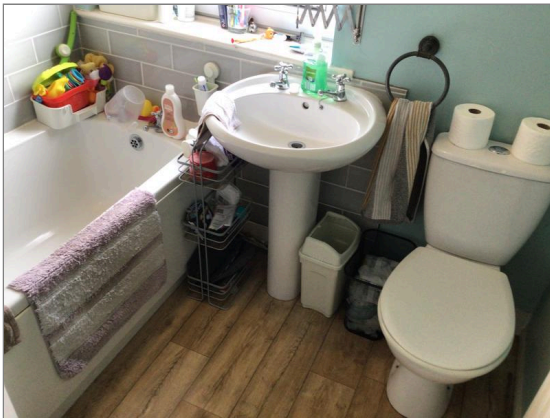
Photo - 8 Bathroom fittings

Sanitary fittings appear to be leaking and will require attention. The electric shower should be tested by a qualified electrician before use, as noted in Section F1. All seals around baths, basins and showers should be maintained in good condition to prevent water penetration and damage to adjacent timbers. Where showers are installed over baths, movement of the bath can cause seals to fail or the bath itself to crack, and leaks are often not immediately obvious. The current shower curtain offers limited water containment, increasing the risk of water escaping; a fixed or hinged screen would offer better protection. No extractor fan is fitted, and bathrooms are prone to condensation and mould without effective mechanical ventilation, so improved ventilation should be considered to help manage moisture levels.

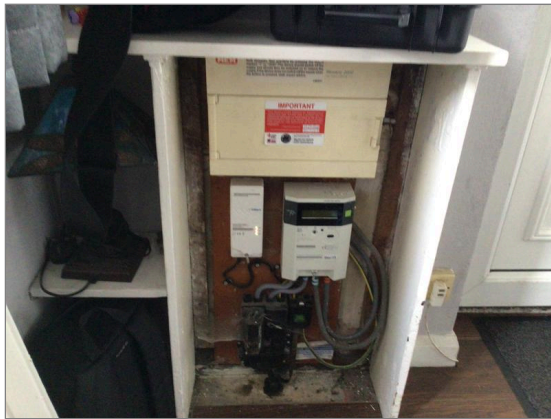
Photo - 10 Meter and consumer unit

Whilst the visible wiring appears satisfactory, if there is no record of an electrical test having been recently undertaken, it is recommended that the installation be tested by a competent electrician (NICEIC/ECA registered) prior to exchange of contracts to confirm its safe operation and so that you are aware of any likely future costs. All recommendations should be implemented. Thereafter, the installation should be re-tested as recommended by the electrician. However, we would strongly recommend an inspection of the electrical system on change of ownership regardless.

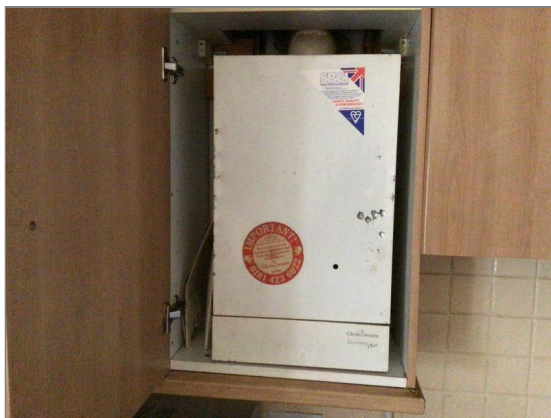
Photo - 11 Boiler

The property is heated by an old gas-fired boiler located in the kitchen, serving radiators throughout. The installation is clearly ageing and is likely to give rise to future problems, so you should instruct a Gas Safe registered heating engineer to carry out a full inspection and functional test of the system prior to exchange and to advise on any necessary repairs or replacement, particularly as no compliance certificate was available. We have not assessed whether the radiators are adequately sized for the accommodation, and the engineer should confirm this as part of their review.

The installation, including any gas appliances and flues, must be tested by a 'Gas Safe' registered contractor prior to exchange of contracts to confirm its safe operation and so that you are aware of any likely future costs. All recommendations should be implemented. Thereafter, the installation should be retested annually.

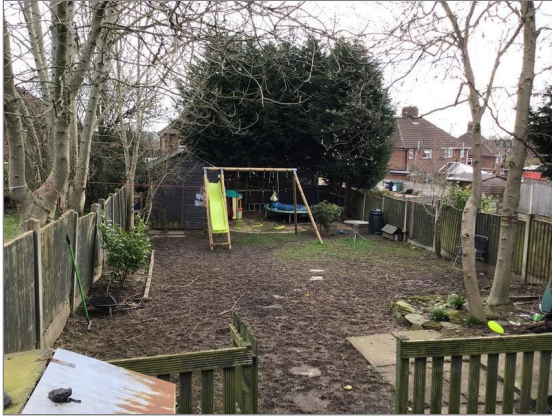
Photo - 12 Rear garden

Some of the walls around the curtilage of the site are substantial retaining structures. Such walls do represent a major repair and financial liability and it is vital that they are inspected on a regular basis and maintained in good condition. Adequate drainage is required for retaining walls and

some improvement may be required in the future.
