# Your survey and valuation report

36 Willow Road, Chester, CH4  
8NY.

31st March 2026

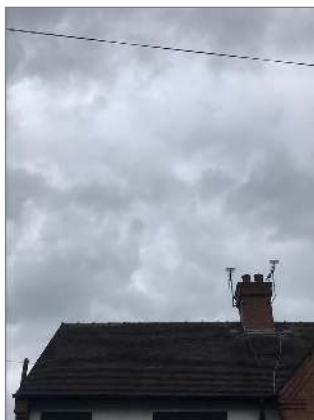
Photo - 7

Typical weathering and loss of surface colouring was noted.

There is no underlying roofing felt. The felt provides a secondary barrier to wind driven rain, roof without under felt and inadequate torching can leak without warning if a tile is lost, damaged or slips. The surface of the tiles is prone to weathering and ridges etc may need repair periodically. One missing tile on the front slope was noted.

This roof has reached the end of its useful lifespan and you should budget for replacement.

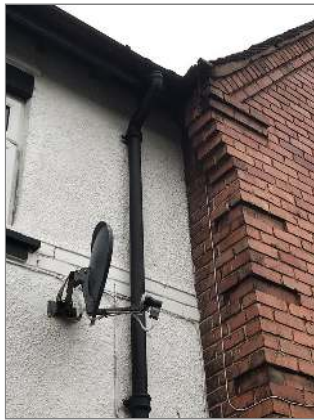
Photo - 9

The gutters and downspouts to this property are of cast iron and parts are corroded. Cast iron can rust and leak without warning and you should plan to replace these soon. Downspouts discharge into open gullies around the site. Gutters and gullies are in need of cleaning.

I would recommend that gutters and joints are maintained on a cyclical basis. In addition, the down pipe should be checked, to ensure that there are no blockages and that water is free flowing. As a precautionary measure it is prudent to clear debris and moss from all gutters. This will extend the life of the gutters and prevent unnecessary repairs to the external envelope. Poorly maintained gutters will cause saturation of the external envelope, which is linked to dampness and condensation.

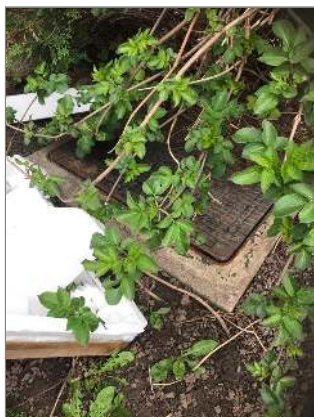
*Photo - 87*

One manhole cover to the property was located, the cover was too heavy to lift limiting the inspection.

It is recommended you obtain a CCTV inspection of the drains before exchange of contracts.

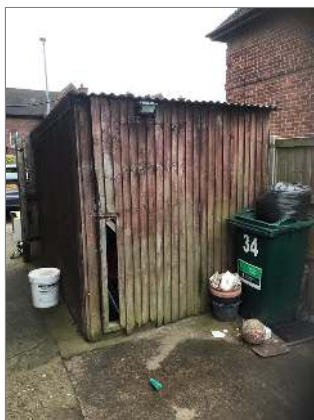
Photo - 88

The timber elements around the sheds have not been well maintained, decay and deterioration is noted.
