# Your survey and valuation report

36 Willow Road, Chester, CH4  
8NY.

31st March 2026

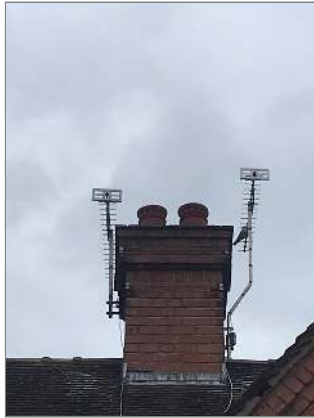
Photo - 2

To repair the chimney safely and avoid damaging the roof covering, contractors will have to use appropriate access equipment (for example scaffolding, hydraulic platforms, etc.).

The owner of the neighbouring property may have a number of legal rights over this shared chimney. You should check with your legal adviser before any work is done (see section H3).

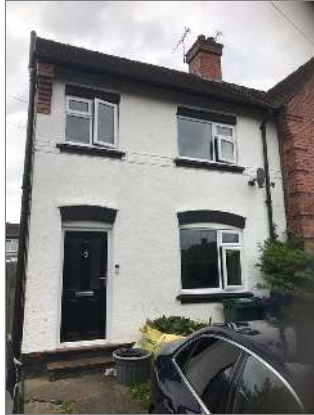
*Photo - 14*

If non-galvanised metal lintels, concrete or wooden lintels have been used, they may corrode / deteriorate over time, leading to expansion and cracking of the surrounding brickwork. Even where

lintels do exist, we cannot assess their long-term performance or effectiveness without specialist investigation.

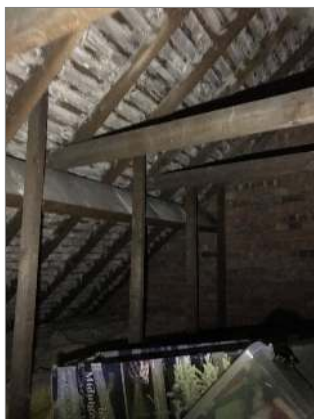
*Photo - 32*

2 Flexible pipe can collapse or get squashed by stored material in the roof space and become ineffective. Rigid pipes are more appropriate and acceptable for longevity.

We always recommend an underfelt to be fitted, if you proceed without fitting an underfelt, you will need to be proactive with the roof with checks especially before winter and after high wind or heavy weather conditions, if a slate is displaced it will leave a direct route into the roof space for wildlife or moisture to enter, we advise getting quotes for this work before commitment to purchase, it will include removing the all tiles from the roof.

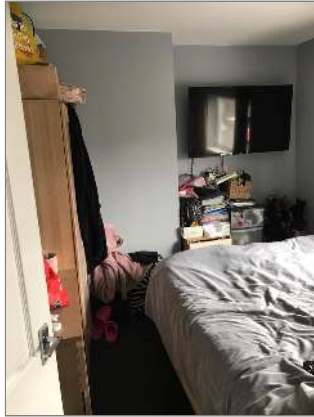
*Photo - 43*

As the readings are based on the Wood Moisture Equivalent scale, it is not appropriate to state

percentages, as there are many contaminants within the plaster work that can distort readings. Therefore, we always recommend that the areas where high readings are detected, is reviewed by an accredited damp specialist. A damp specialist will perform a Carbide test that will provide a more accurate reading of moisture content within the fabric of the wall.

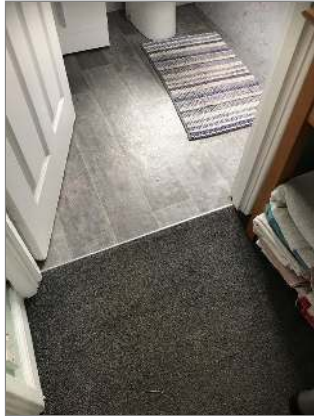
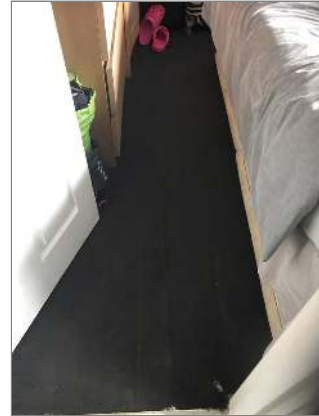
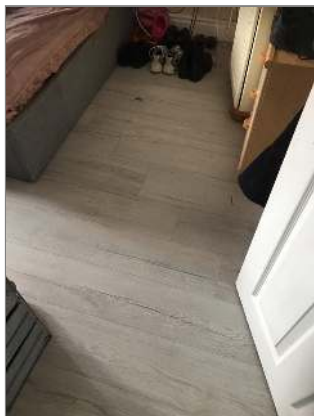
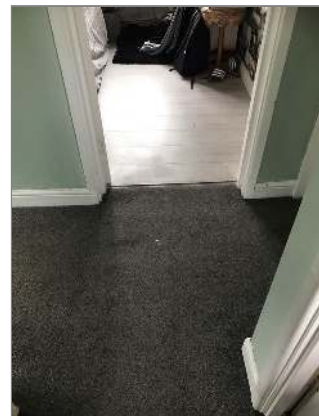
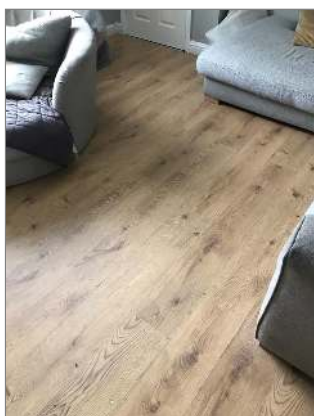
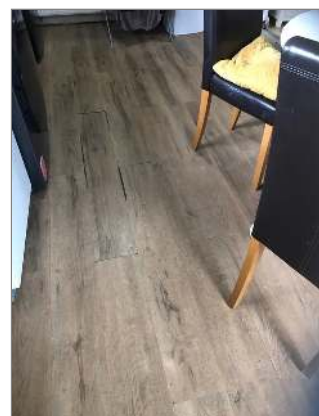
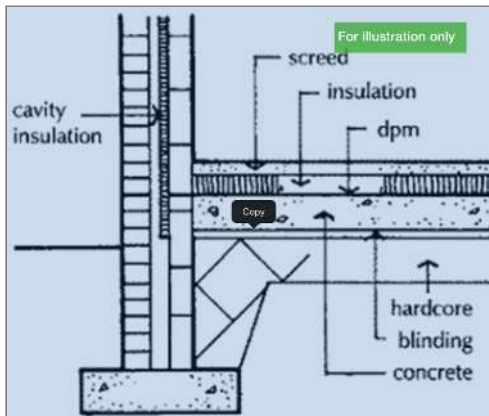
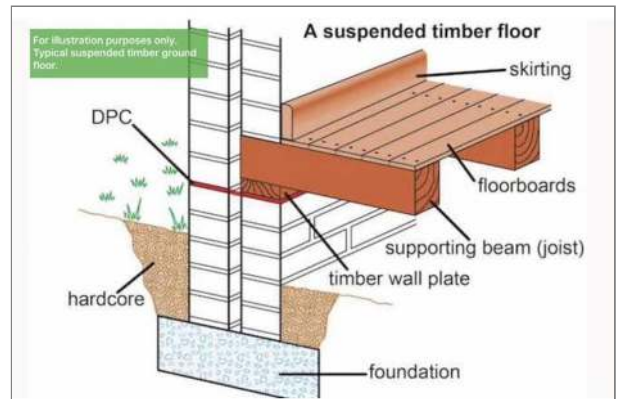
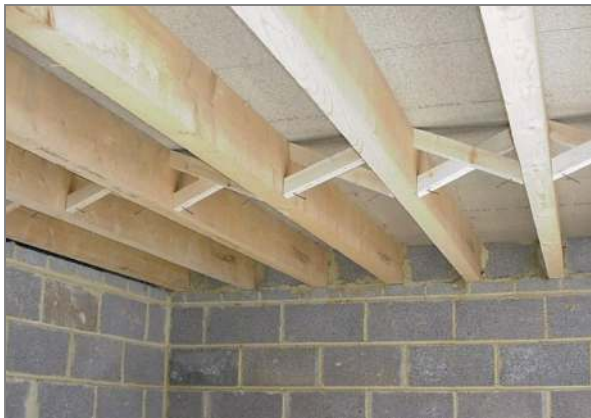
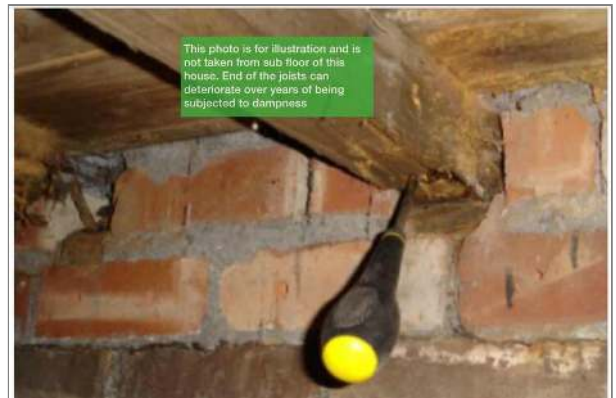
The living room floor is of traditional timber joist and boarded construction and was reasonably level with no significant distortion or deflection under a 'heal drop' test. We have not checked the condition of the sub floor joists for any decay. It is recommended that sub-floor joists are lifted and checked for signs of decay and structural integrity.

Suspended timber upper level floors consist of timber floor boards being attached to floor joists. The timber floor appeared to be level with some minor creaking noted. Creaking floorboards to the first floor should be checked to ensure the correct fixings have been used.

We did not lift any fixed coverings or floorboards at ground or upper floor to inspect the floors / sub floors below, with elements of damp noted, we recommend the floors should be exposed by a qualified contractor to check for decay to joists and the subfloor condition, prior to purchase.

The only way to confirm the condition of the floor joists and sub-floor, is to instruct a suitable contractor to open up part of the floor to inspect before you commit to purchasing the property. If there are defects to the joists or they are damp you should instruct a CSRT certified specialist registered with the Property Care Association to specify a repair and obtain quotations for the works before you commit to purchase. This is a precautionary measure.

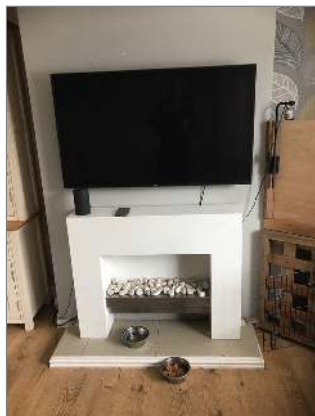
Photo - 63

The chimney breast appears to be adequately upright and free from significant distortion which would suggest that it is suitably supported. There are no fires, appliances or fireplaces.

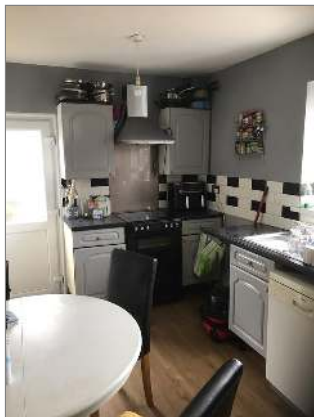
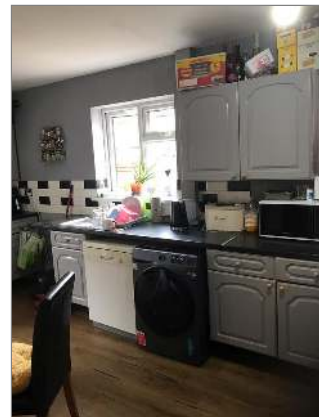
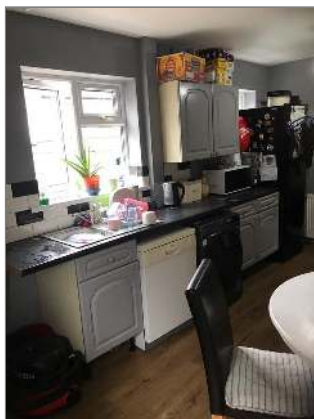
The kitchen to the property appears to be in an old but serviceable condition. There are wall and base cupboards with laminate worktops and a stainless steel sink unit. Integrated extraction hood. Plumbing and space for washing machine and dishwasher.

Where an appliance has to be replaced, it can be very difficult to find a replacement that matches the others in the room. As a result, you may wish to replace the whole suite. Replacement of the kitchen will enhance the property.

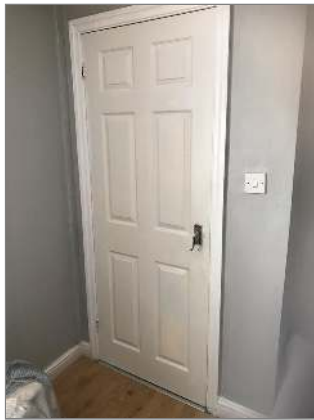
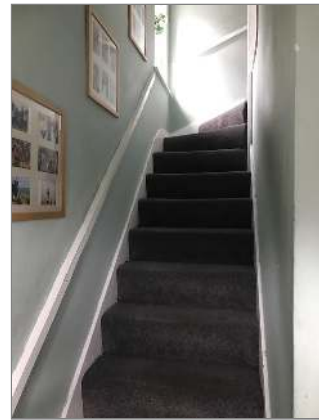
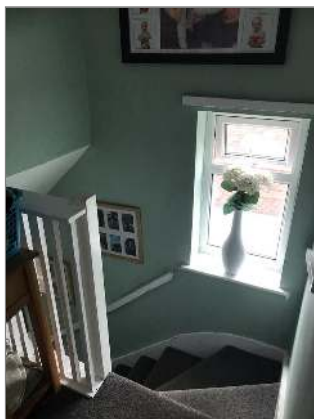
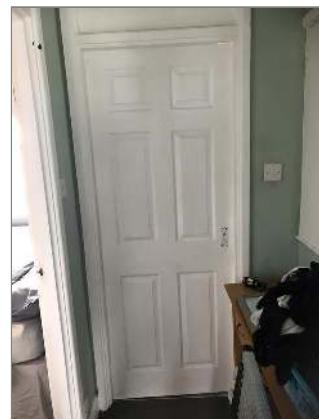
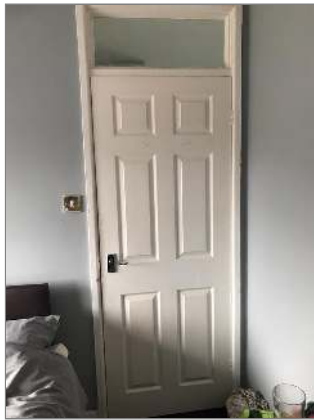
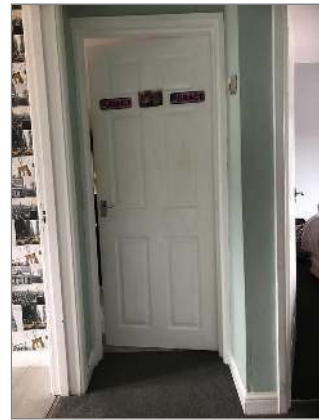
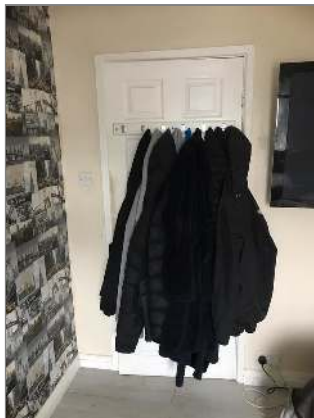
Internal joinery is generally in reasonable condition for age and type. Doors in the property are replacement doors and ironmongery and are of pressed timber boarded doors. The living room door handle needs replacing and the bathroom/bedroom 3 need door handles installed.

The staircase giving access to the upper level is of adequate width and pitch for a house of the age and type. Adequate balustrading was noted but the handrail has been removed, hand rails to staircase should be continuous and extent to the base of the staircase. Treads can loosen due to normal usage causing creaking, treads may require tightening periodically. Only minor creaking was noted.

Over time, the wood to staircases can shrink and split loosening the various joints causing the stairs to creak when used. This is not a safety hazard, but you should overhaul and repair the stairs soon. Creaking to the staircase can have many reasons however, holding blocks, should be well glued and screwed to the back of the riser and underside of the tread.

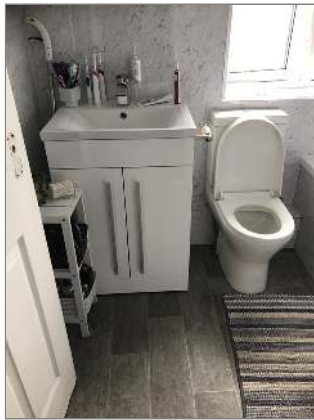
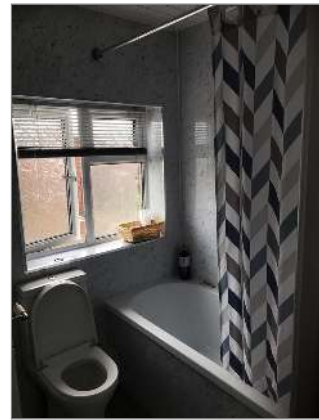
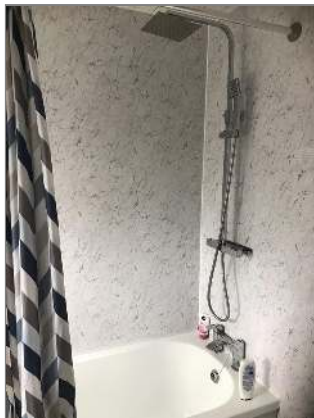
The existing sanitary fittings to the bathroom all appear to be in a modern and serviceable condition.

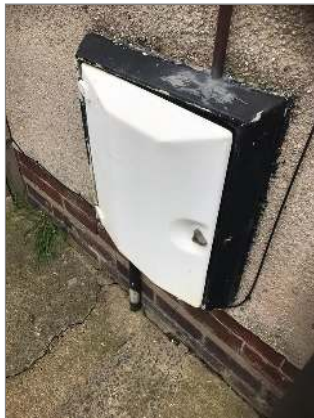
Photo - 78

Regulation states that in the absence of a current test certificates we must designate a level three risk.

All gas installations to be checked and certified by a gas safe engineer.

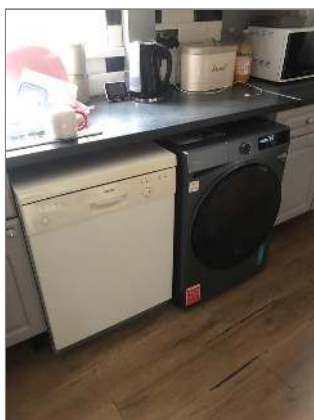
Photo - 79

Incoming water supply pipe may be of copper, Alkathene (plastic) or lead. Lead pipes are vulnerable to leakage and also considered as unhealthy. It is not always possible to see the incoming water main and therefore identify the type. Bringing a new supply into the house could be expensive depending on where the main supply is. If this was necessary then there are certain regulations that apply. These investigations should be carried out soon.

Please note that no intrusive methods of investigation were carried out to assess whether any plumbing faults exist. We recommend you have the plumbing checked before commitment to purchase.

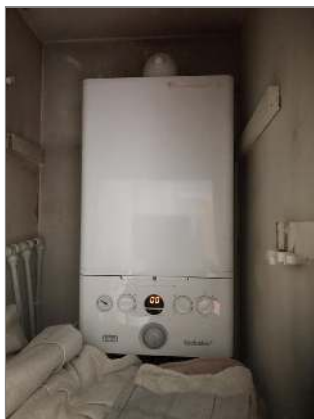
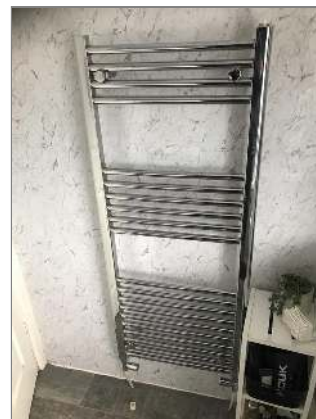
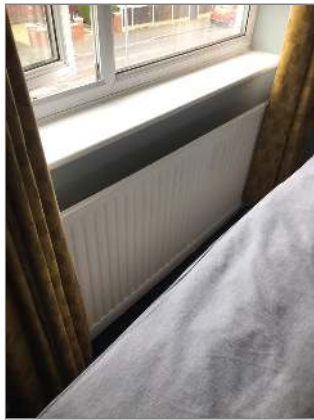
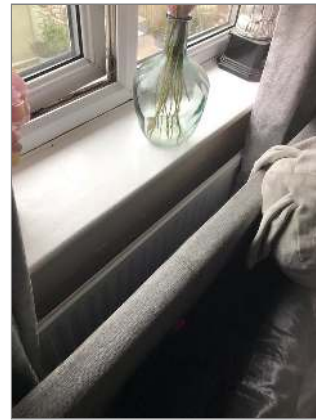
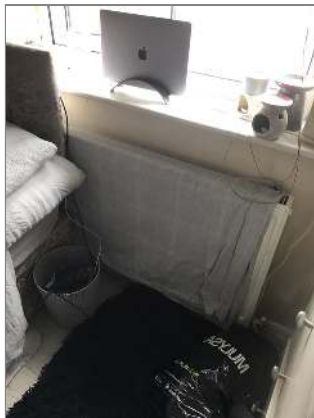
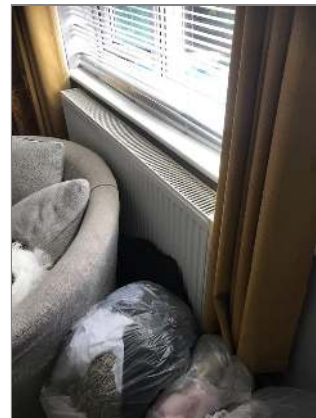
In the absence of a current test certificate, we must designate a level three risk. If certification is available, please ask your legal advisor to check the validity of this evidence. All gas installations to be checked and certified by a Gas Safe engineer prior to purchase, unless evidence of recent testing can be provided.

Please ensure you have a carbon monoxide alarm near all fuel burning appliances.

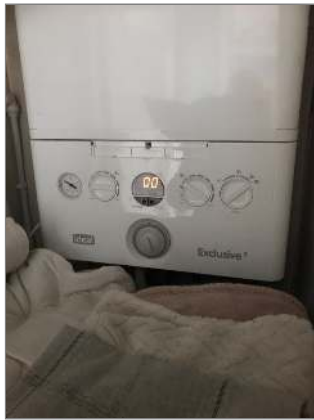
Photo - 86

In the absence of a current test certificate, we must designate a level three risk. If certification is available, please ask your legal advisor to check the validity of this evidence. All gas installations to be checked and certified by a Gas Safe engineer prior to purchase, unless evidence of recent testing can be provided.

Please ensure you have a carbon monoxide alarm near all fuel burning appliances.

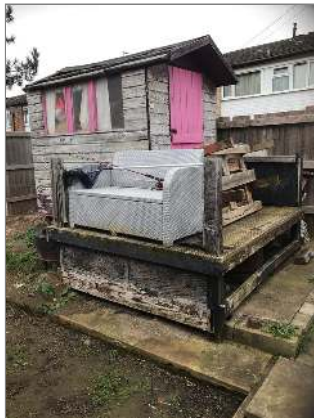
Photo - 90

The property has three timber store sheds which are generally in poor condition.

The timber elements around the sheds have not been well maintained, decay and deterioration is noted.

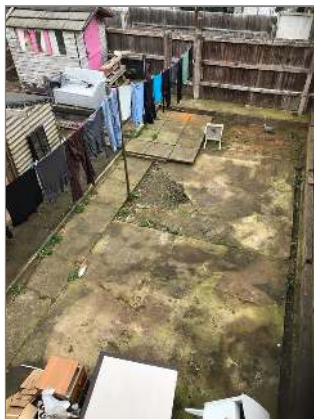
Photo - 91

The property is situated on an average sized plot for a property of this age and type. The gardens are predominantly surfaced with concrete. The gardens require an overhaul. Ownership and the precise position of boundaries are not apparent from our site inspection. Your Legal Adviser should check accordingly particularly in respect of maintenance liabilities. Only a very general inspection of the boundaries has been made and all boundaries appeared in an acceptable condition. Fences are particularly susceptible to decay at their bases, necessitating repairs and a replacement periodically.
