# Energy Performance Certificate (EPC) Scotland

**HARDTYMES, 14 BROOMFIELD GARDENS, STRANRAER, DG9 7EZ**

# Single Survey

# Mortgage Valuation Report

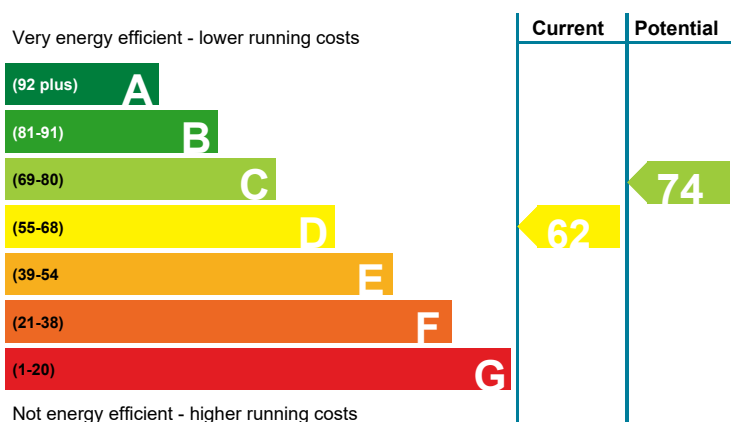
## Energy Efficiency Rating

This graph shows the current efficiency of your home, taking into account both energy efficiency and fuel costs. The higher this rating, the lower your fuel bills are likely to be.

Your current rating is **band D (62)**. The average rating for EPCs in Scotland is **band D (61)**.

The potential rating shows the effect of undertaking all of the improvement measures listed within your recommendations report.

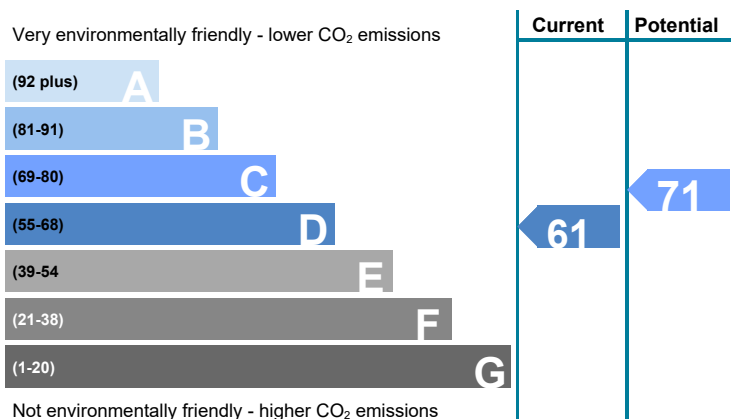
## Environmental Impact (CO<sub>2</sub>) Rating

This graph shows the effect of your home on the environment in terms of carbon dioxide (CO<sub>2</sub>) emissions. The higher the rating, the less impact it has on the environment.

Your current rating is **band D (61)**

The potential rating shows the effect of undertaking all of the improvement measures listed within your recommendations report.

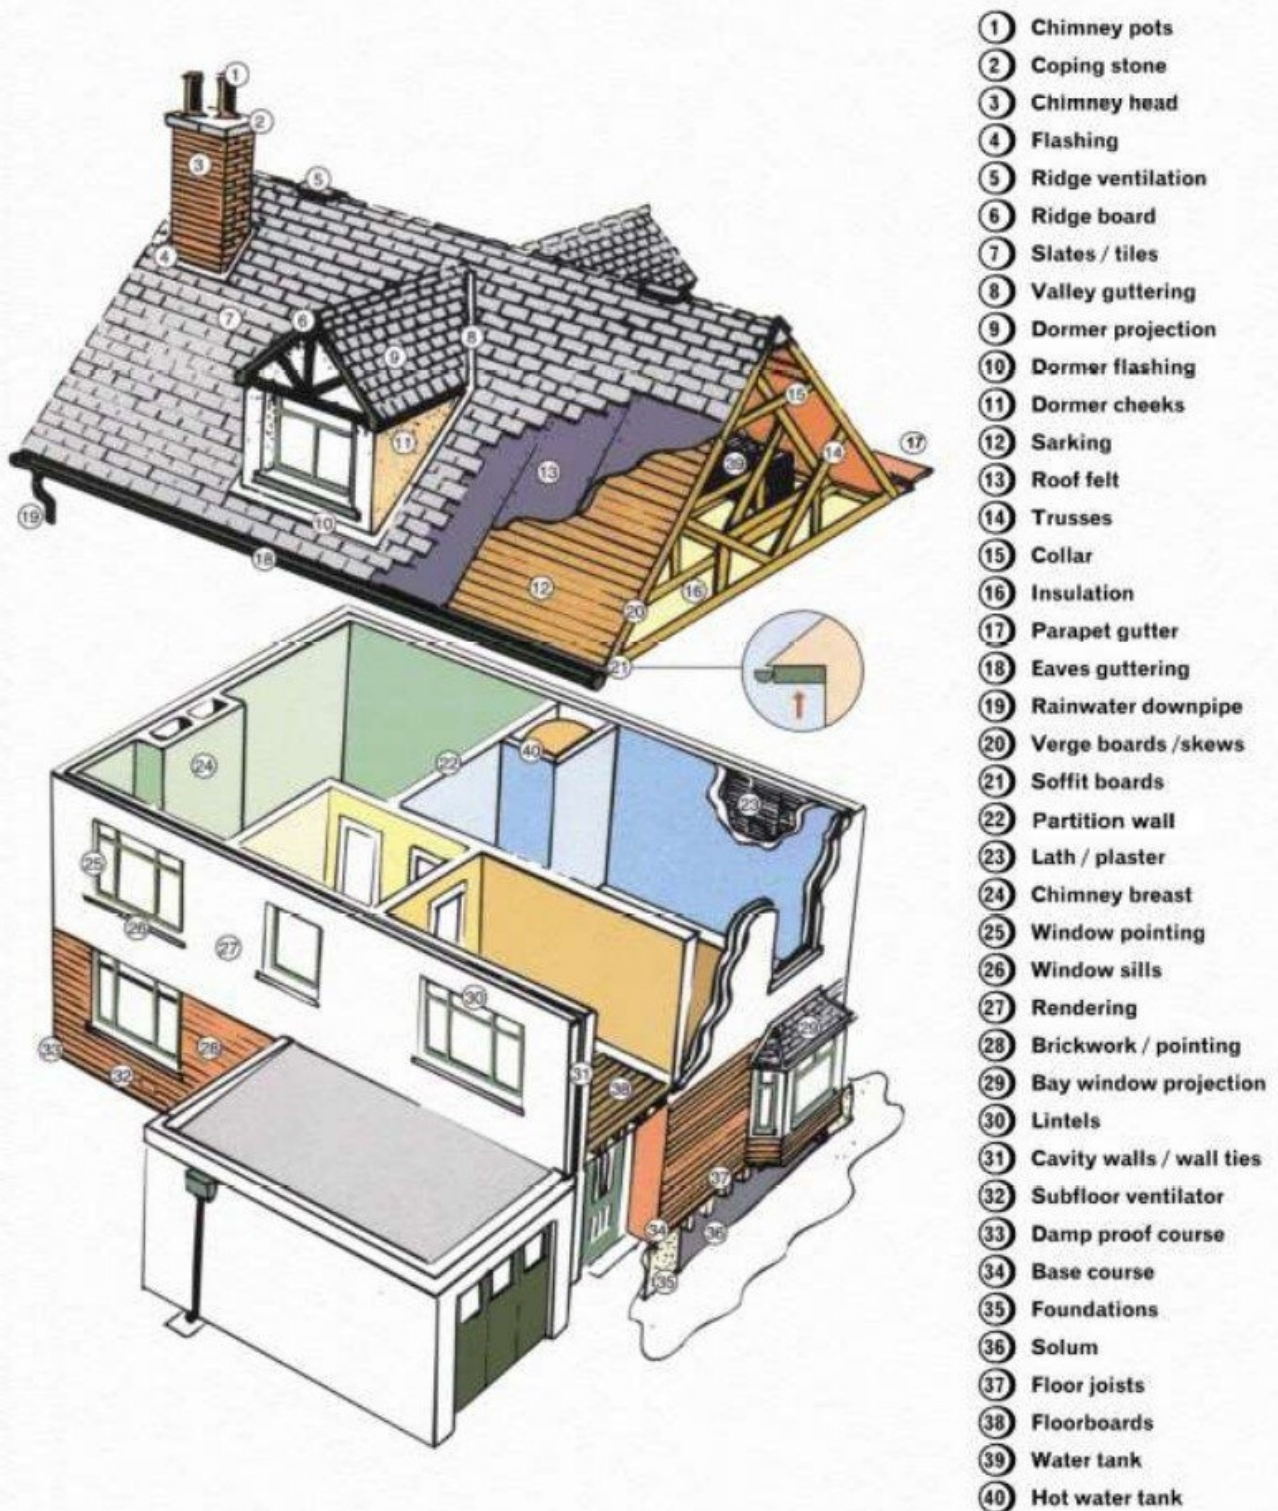
## Sectional Diagram showing elements of a typical house

Reference may be made in this report to some or all of the above component parts of the property. This diagram may assist you in locating and understanding these items.

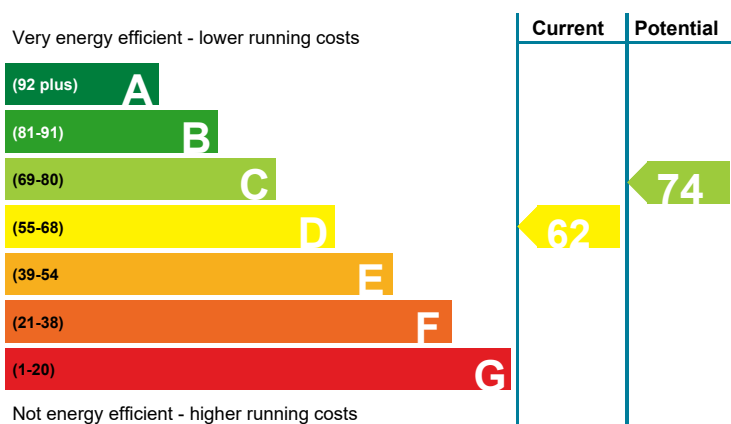
## Energy Efficiency Rating

This graph shows the current efficiency of your home, taking into account both energy efficiency and fuel costs. The higher this rating, the lower your fuel bills are likely to be.

Your current rating is **band D (62)**. The average rating for EPCs in Scotland is **band D (61)**.

The potential rating shows the effect of undertaking all of the improvement measures listed within your recommendations report.

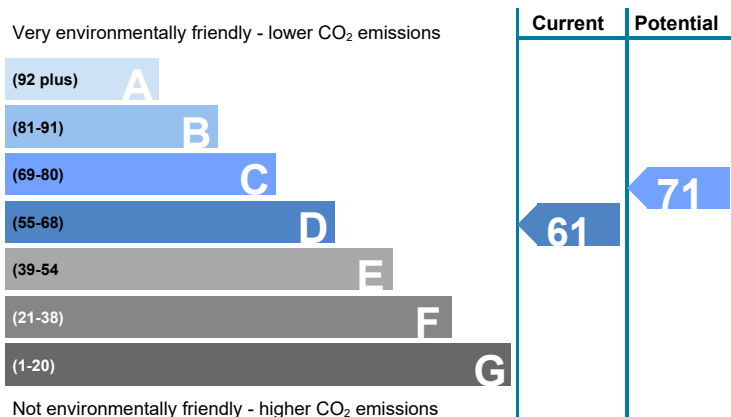
## Environmental Impact (CO<sub>2</sub>) Rating

This graph shows the effect of your home on the environment in terms of carbon dioxide (CO<sub>2</sub>) emissions. The higher the rating, the less impact it has on the environment.
