LEVEL 2

Your survey and valuation report

5 Rock Terrace, New Brancepeth, Durham,
Durham, United Kingdom, DH7 7EP

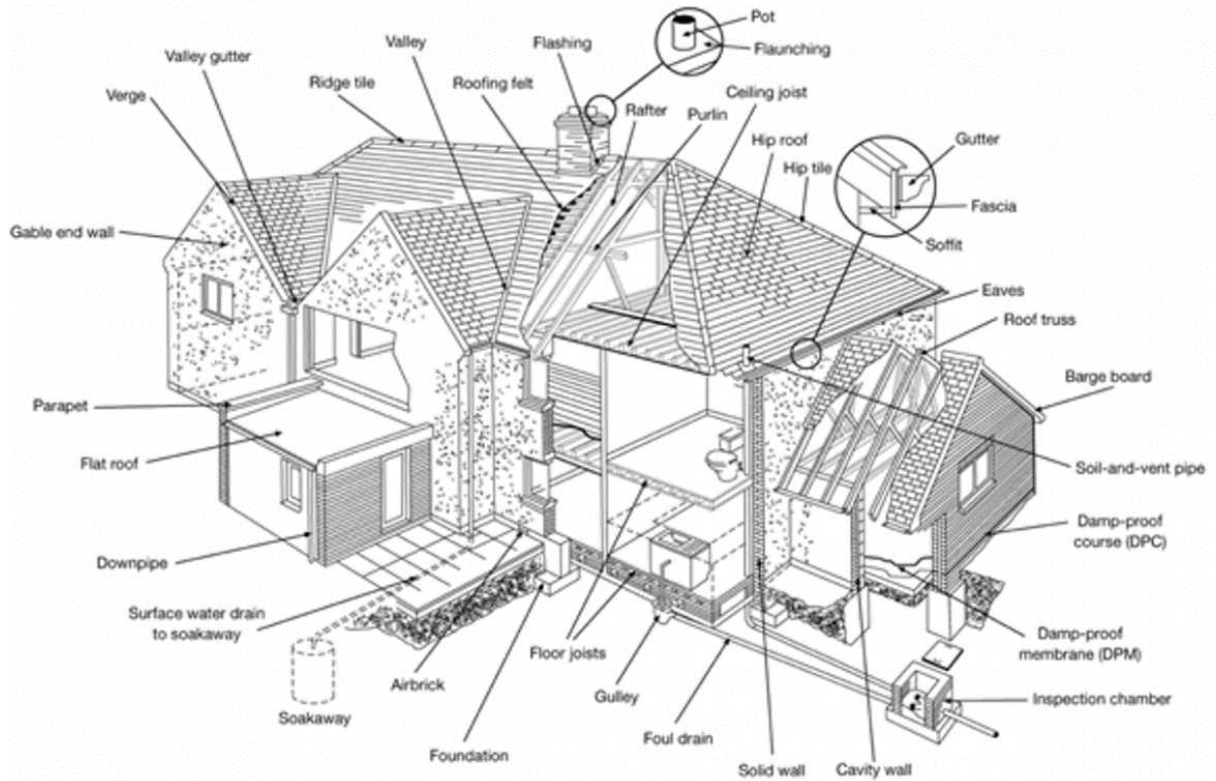
Typical house diagram

This diagram illustrates where you may find some of the building elements referred to in the report.
